Celestron Nexstar GPS 11 Removal and Replacement of Azimuth Clutch (Slip Joint)

by Adrian C. Richards

December 17th 2004

Part One: Removal

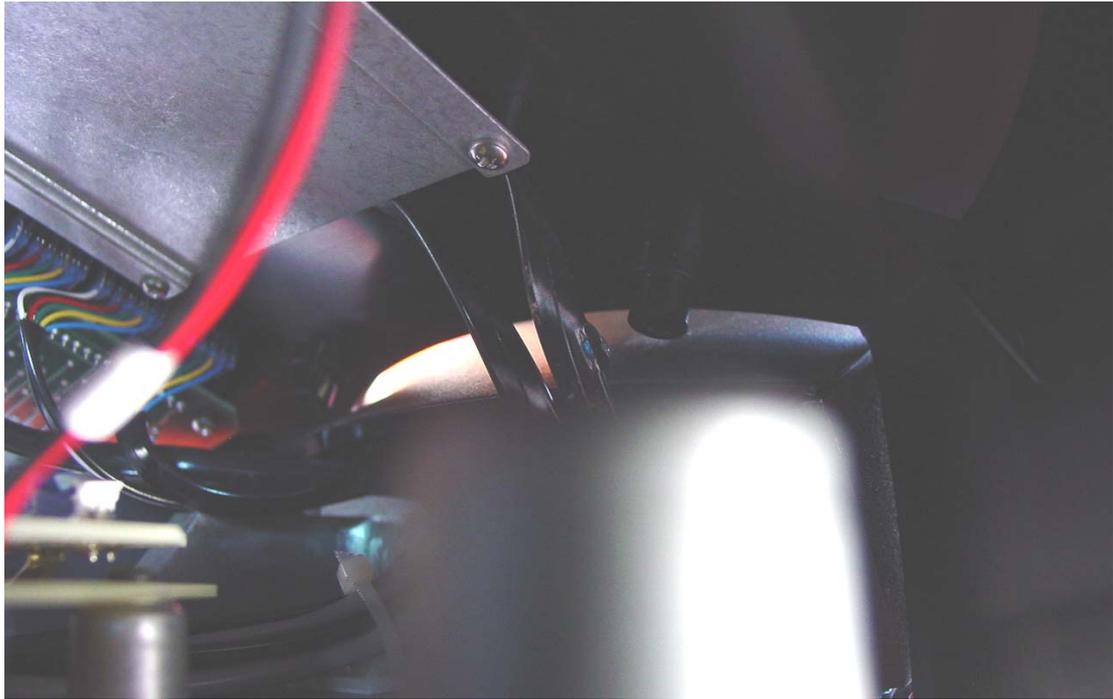
On mine I noticed that the factory assembler neglected to move the wire out of the way before securing the base top cover and pinched off a bit of the insulation from the wire going up into the fork arm! Luckily it did not pinch all the way through to the wire itself. You may want to pay special attention to this during reassembly as there are wire on both sides going up into the fork arm to move out of the way before securing the base top cover!

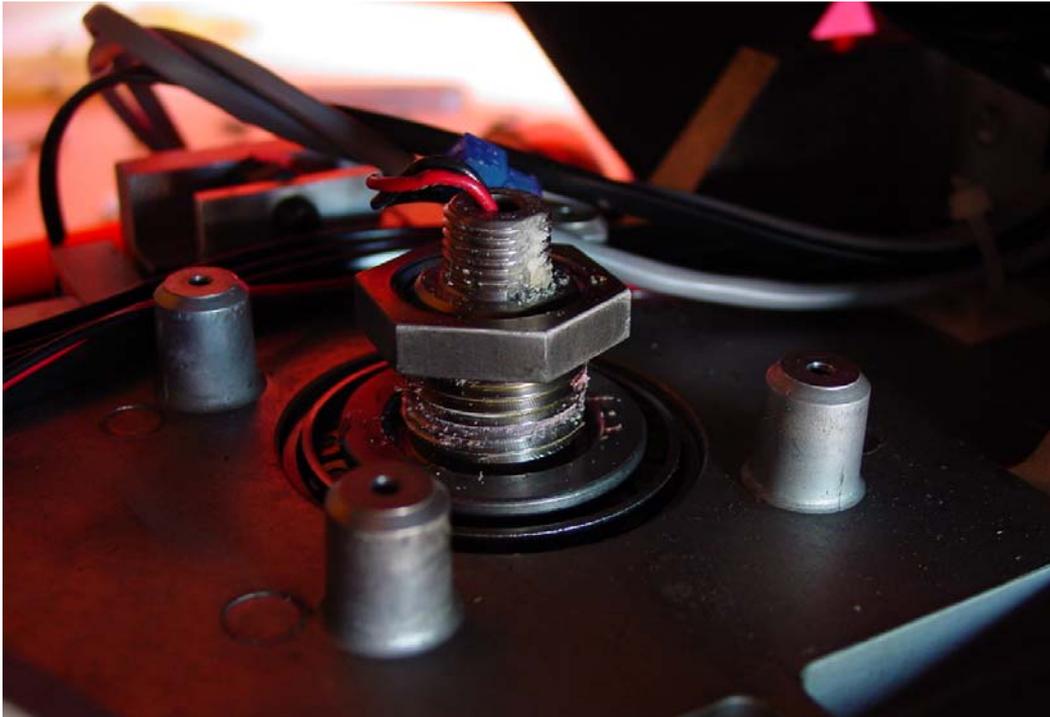
Now remove the large nut holding the upper assembly to the base. I used a 1 1/8", 12 point socket to achieve this. Pay attention to the wire in the center of the shaft so as not to twist it off. I lifted off the socket and straightened out the wire at every turn! The crud you are seeing is due to the "loctite" (locking laquer). You might as well go get a bottle for reassembly as soon as you order your parts (s).

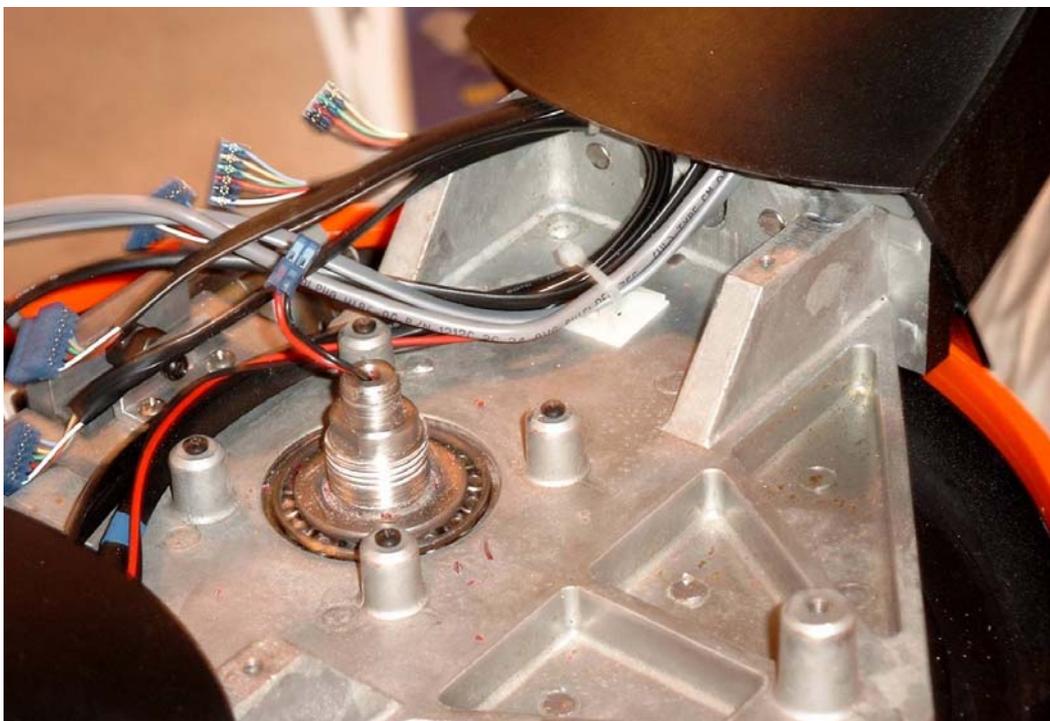
Above photo thanks to Kevin Yahoo Nexstar GPS Group

NOTE: Some have reported that too much loctite has been to the threads of some scopes as shown in the above photo. In such a case, the nut is not easily removed and the upper assembly does not just lift off and alternate methods must be used.

I recommend extreme caution and an extra set of hands. Extra force may be required!

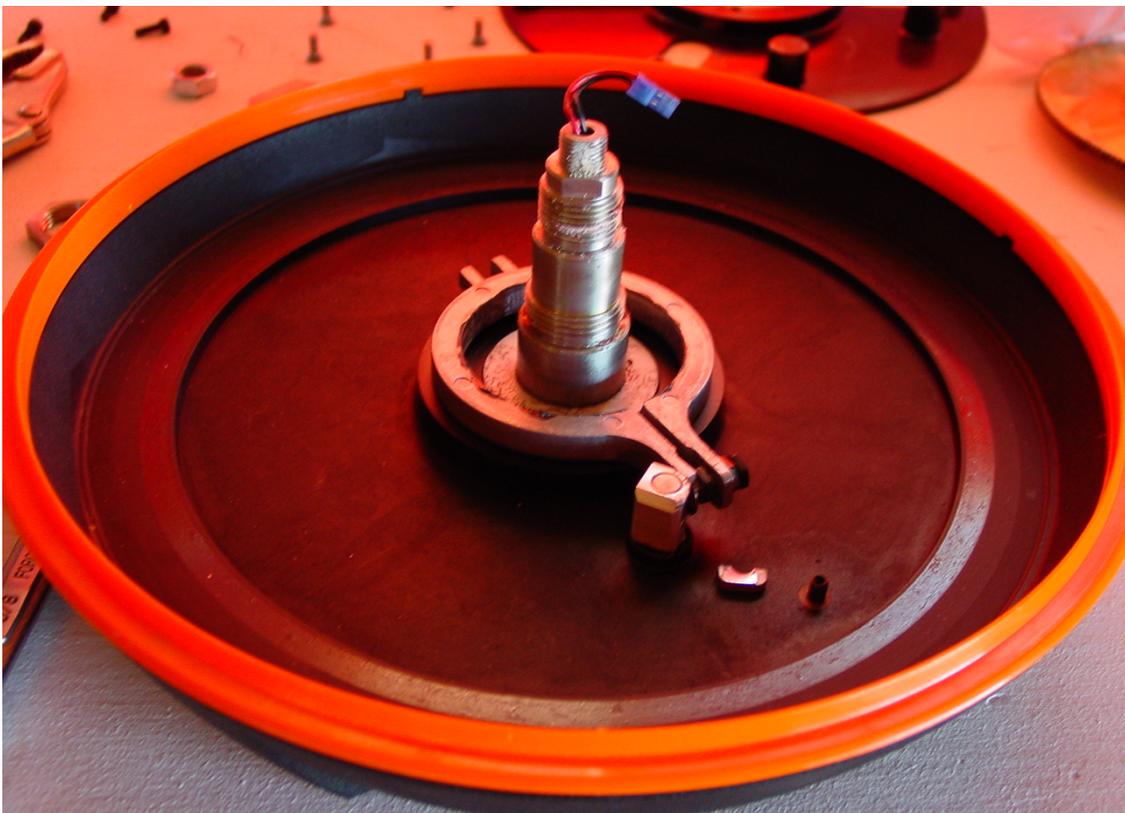
Most likely you will now see what the problem is!

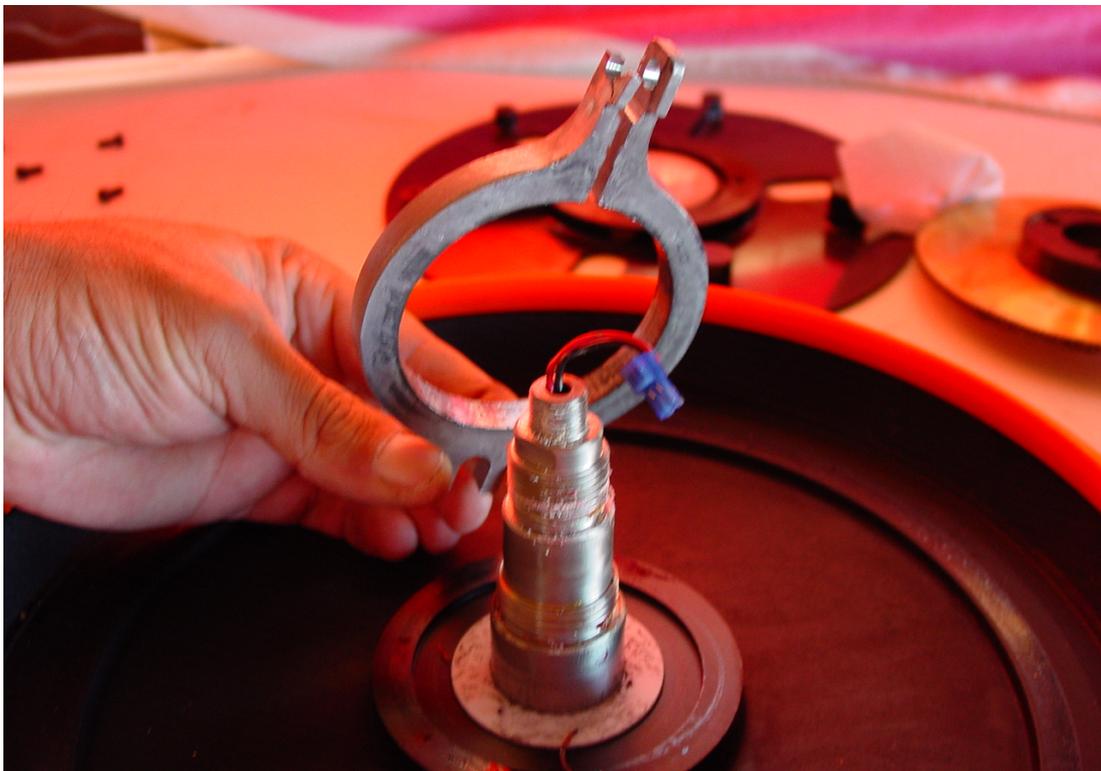
Remove the Clutch and go order the part!

As for my feelings, it was an easy disassembly, but I don't feel this kind of damage should have occurred from normal use, especially when the tension has never been adjusted! Place all of the parts in a clean environment until you get your new parts. I used the giant 80 gallon trash bags and place a beach towel under the bag to keep out the light.

That being said, the non-warranty price quoted by Celestron Inc. USA for the parts are as follows: Azimuth Lever \$21.00, Ring Clamp \$11.00, S & H \$5.00
