Dressler ARA-30 active antenna - what's inside ?

Matthias DD1US
December 2nd 2017

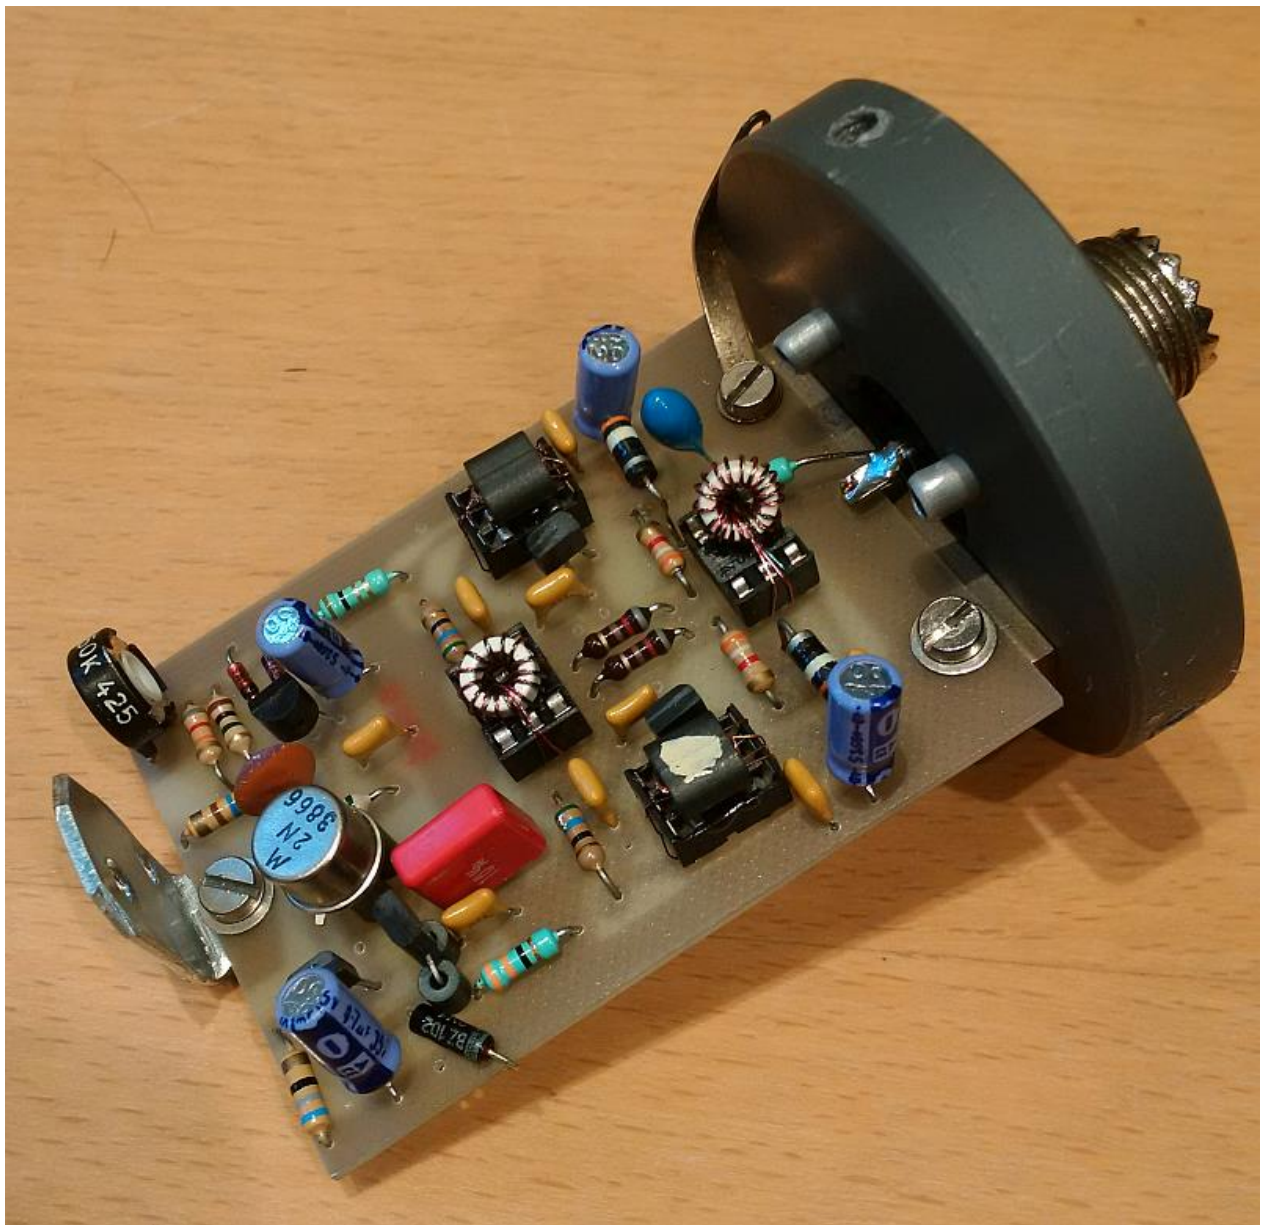
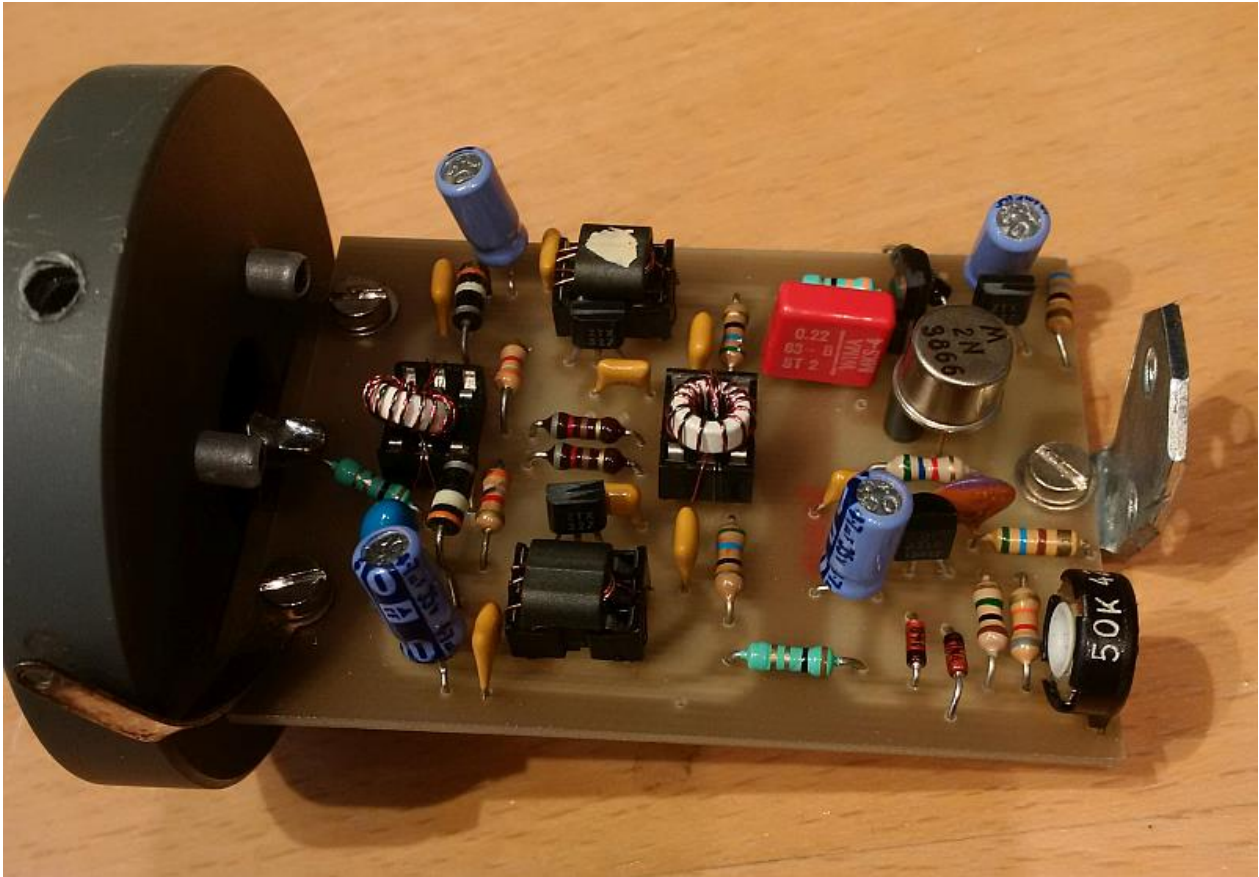
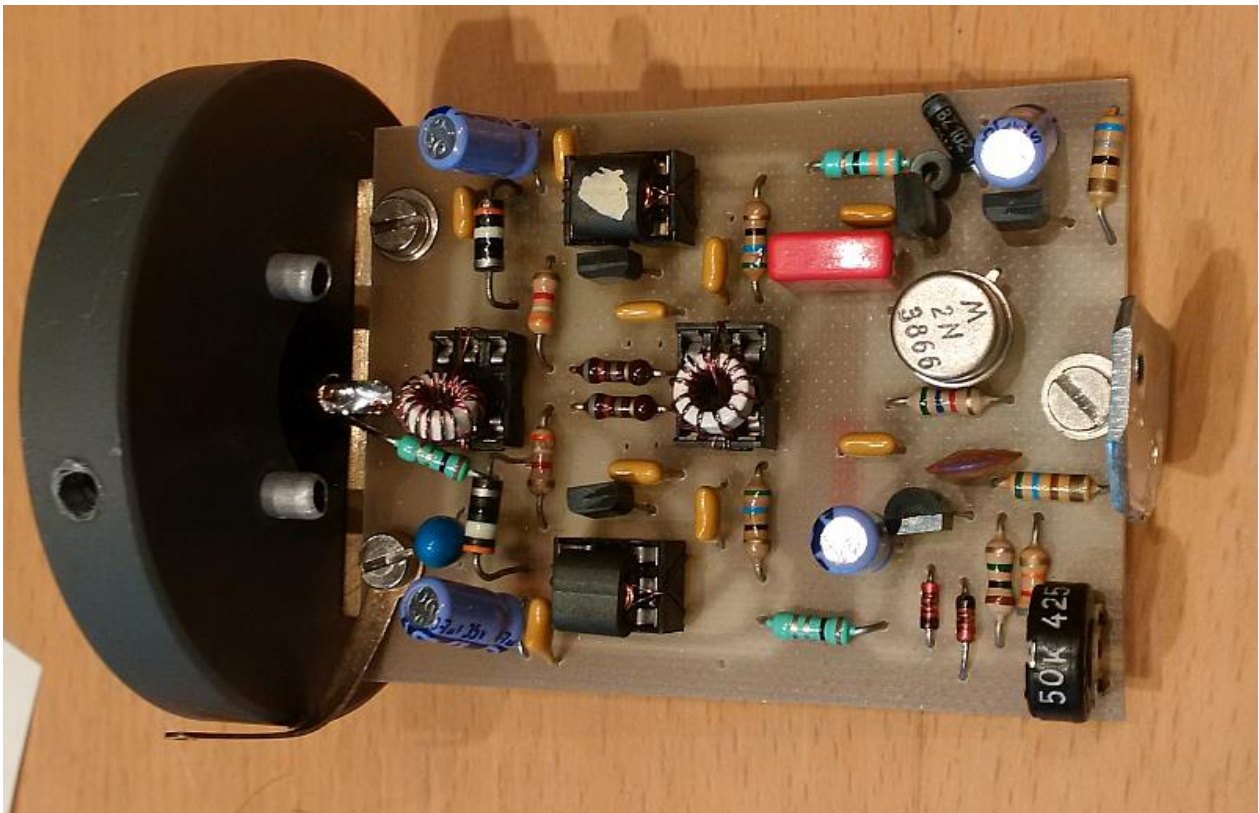
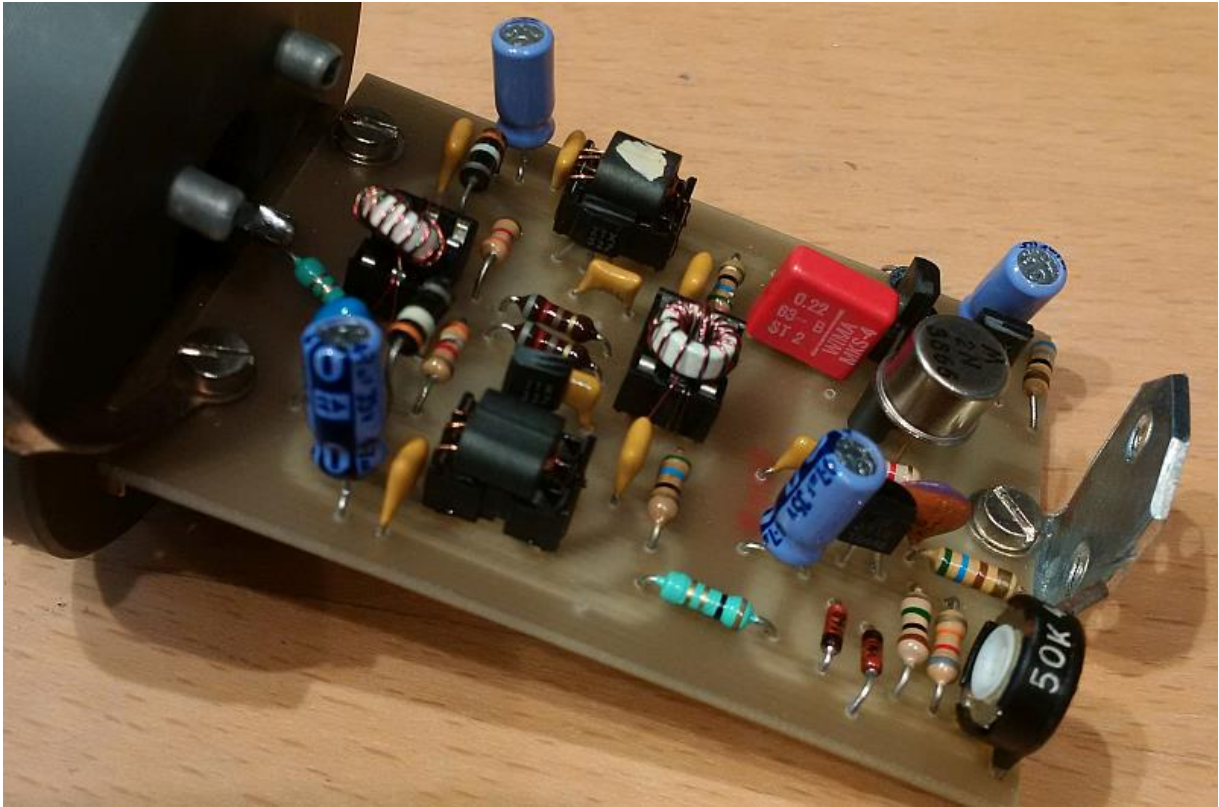
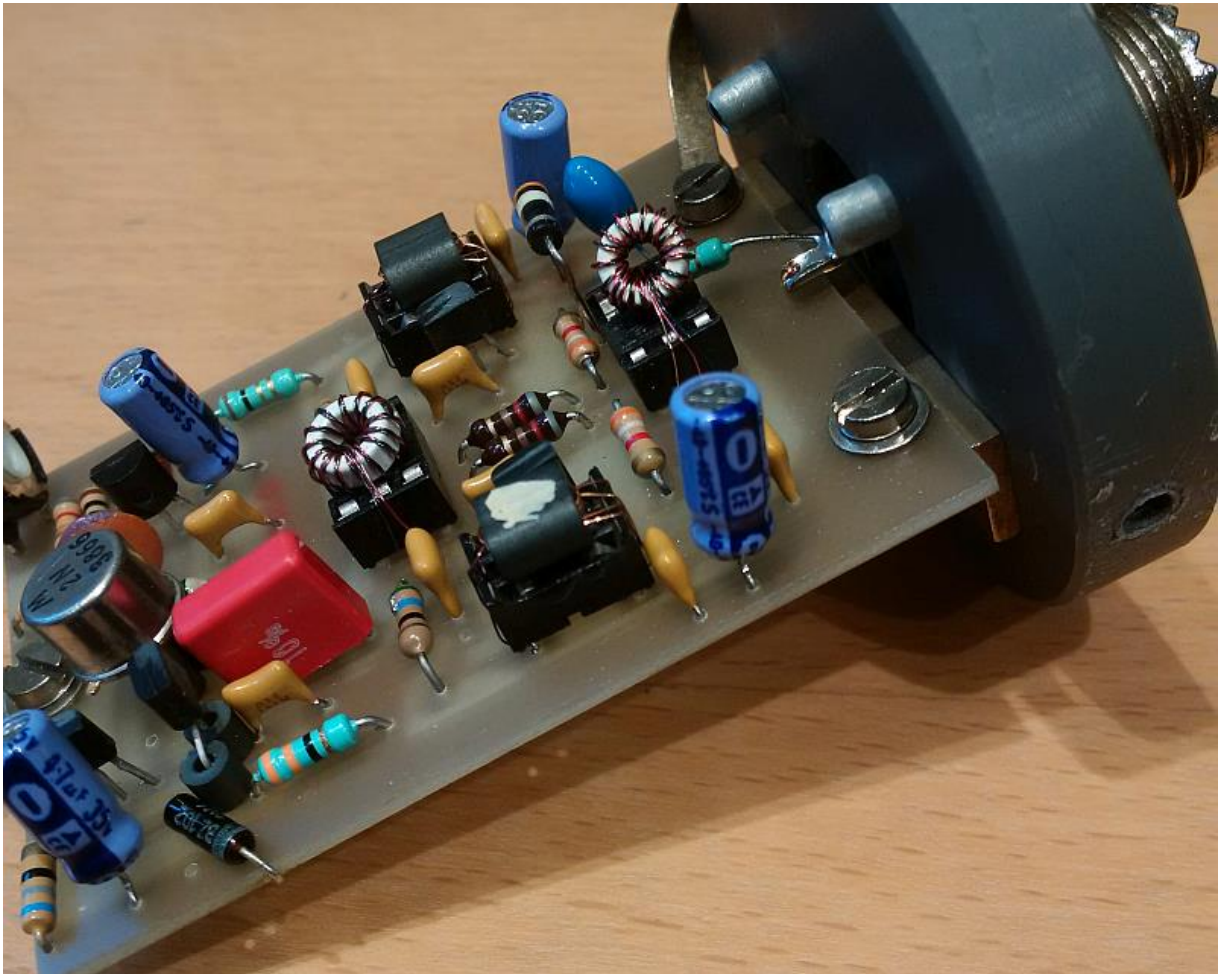
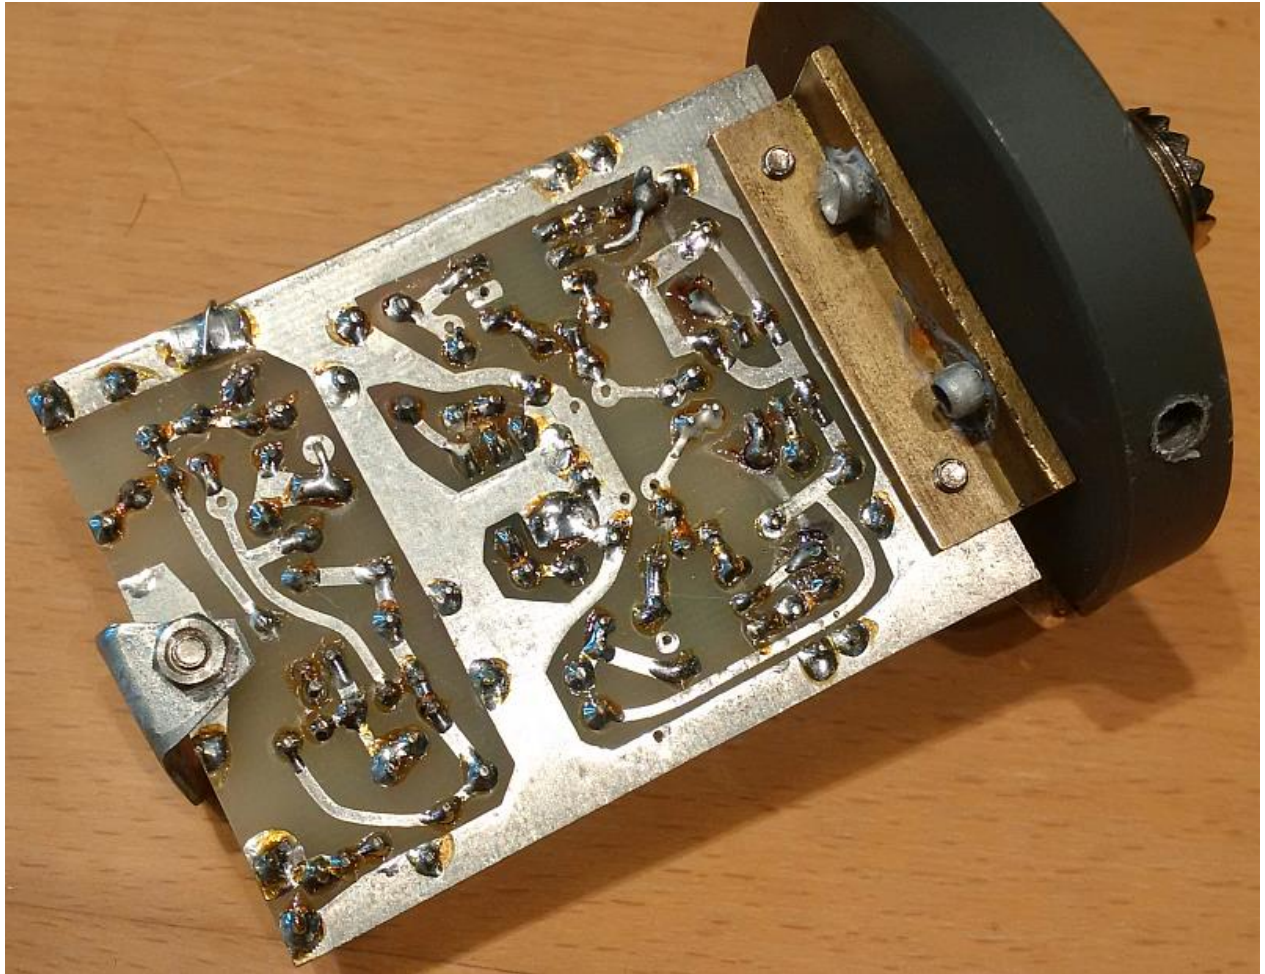
Here are pictures of the PCB in the ARA-30 which I think is nice made.

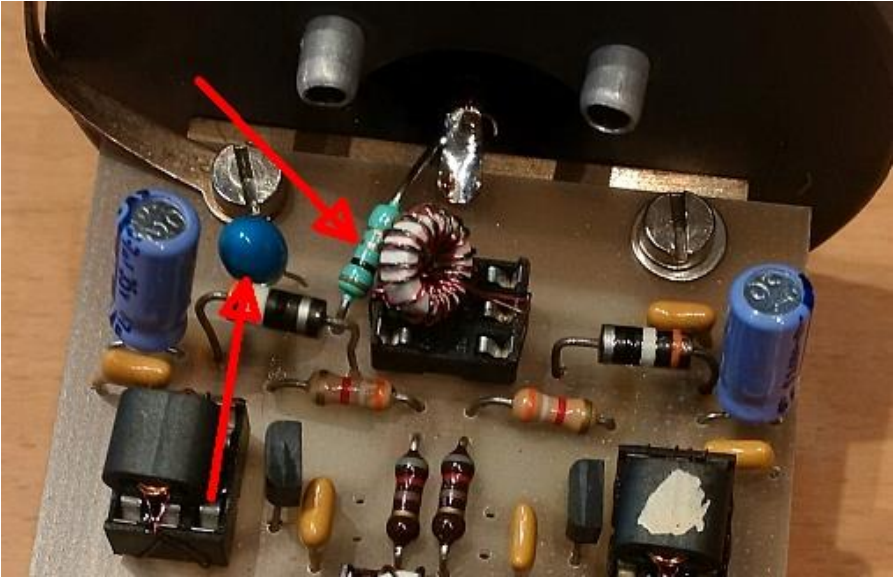
I found out that a tantalum capacitor was damaged and provided a short circuit. I think it is a bad idea to use tantalum capacitors in such a circuit especially the one which was damaged was only rated for 16V (all other electrolyte capacitors on the PCB have at least 25V ratings). In addition a resistor was damaged and had an infinite high resistance. This might have been a consequence of the defective capacitor.
