Celestron Nexstar GPS 11 Removal and Replacement of Azimuth Clutch (Slip Joint)

by Adrian C. Richards

December 17th 2004

Part One: Removal

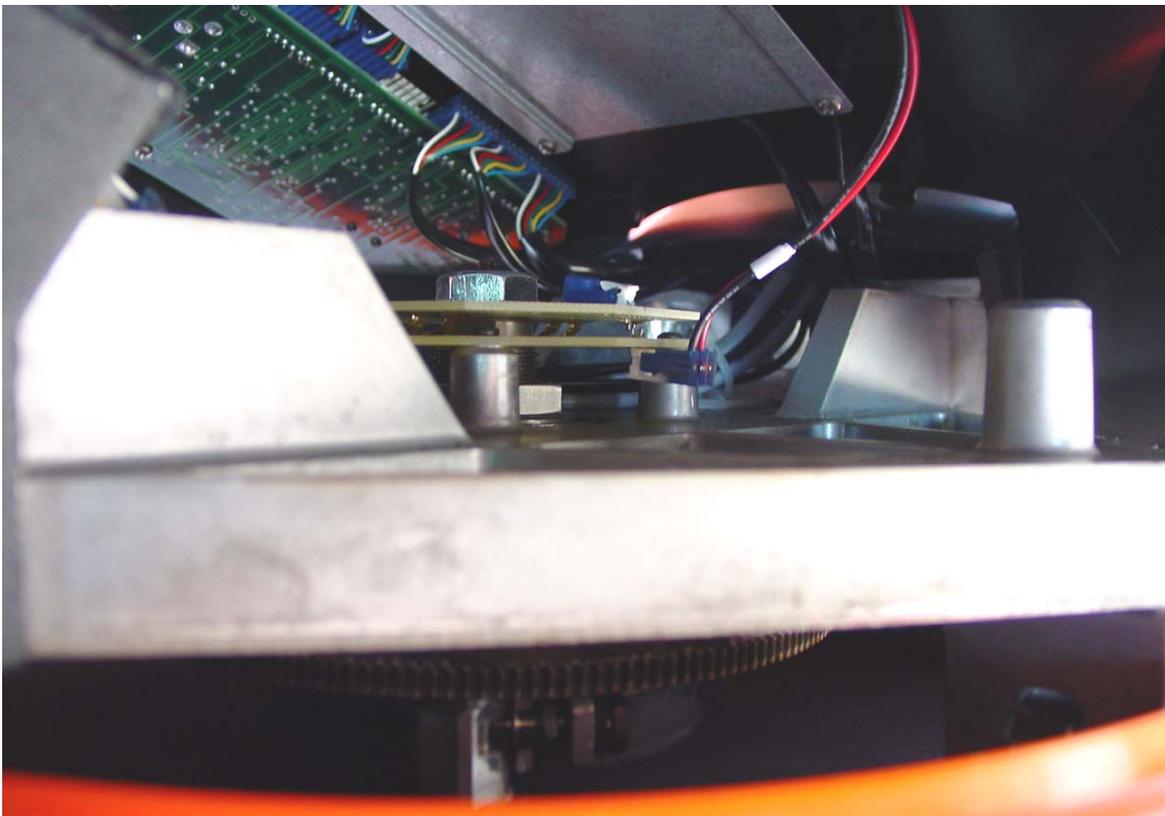
Take out the 5 allen head screws from the top base cover. Gently lift up. Position the cover as shown so you can have a look see.

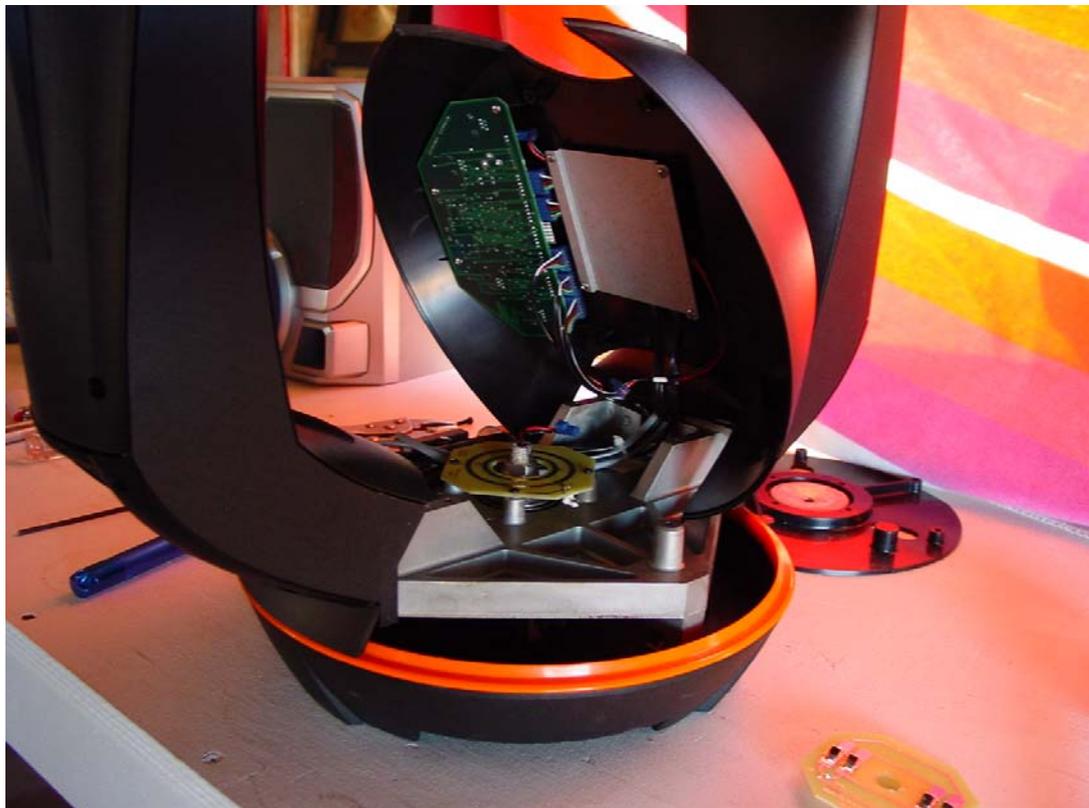
On mine I noticed that the factory assembler neglected to move the wire out of the way before securing the base top cover and pinched off a bit of the insulation from the wire going up into the fork arm! Luckily it did not pinch all the way through to the wire itself. You may want to pay special attention to this during reassembly as there are wire on both sides going up into the fork arm to move out of the way before securing the base top cover!

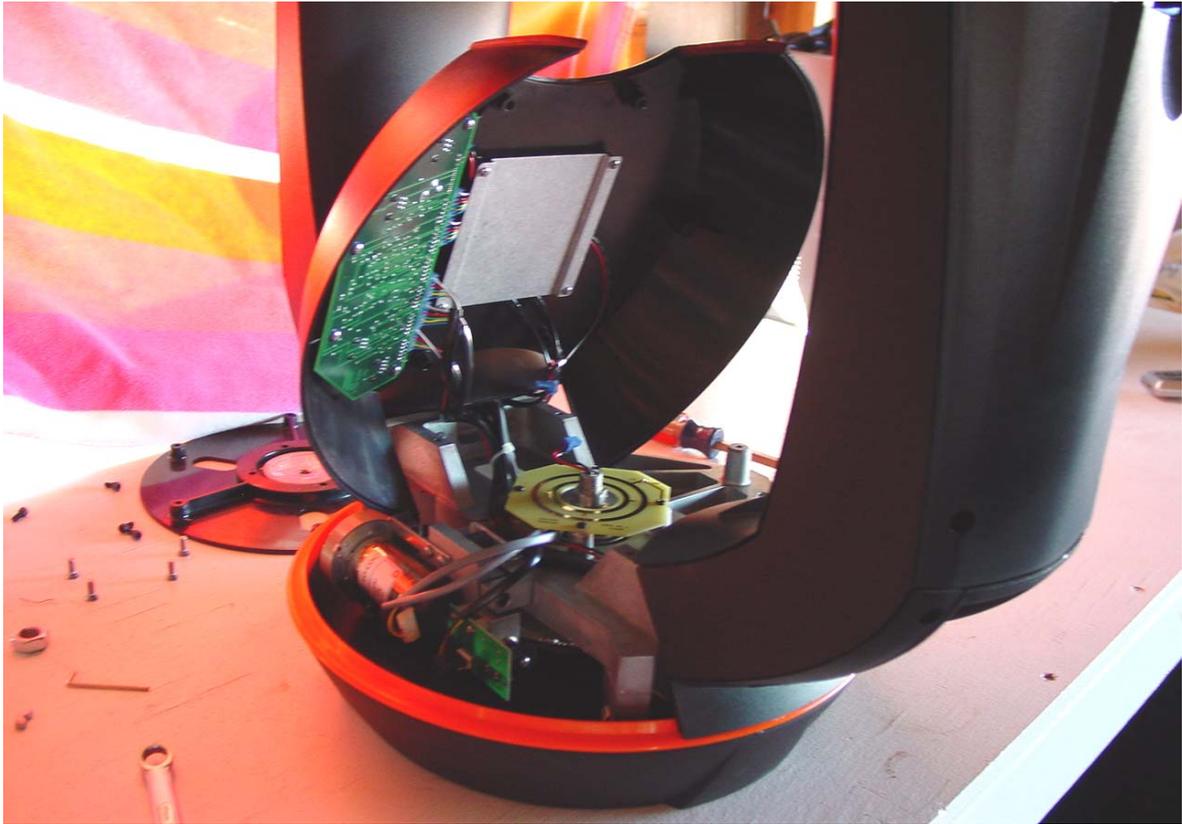
Once you have had a look. Disconnect the two wire connector from the position plates. Then gently pull on the wires going into the fork arm to take up the slack and give you a little room to set the BTC into a better position as shown.

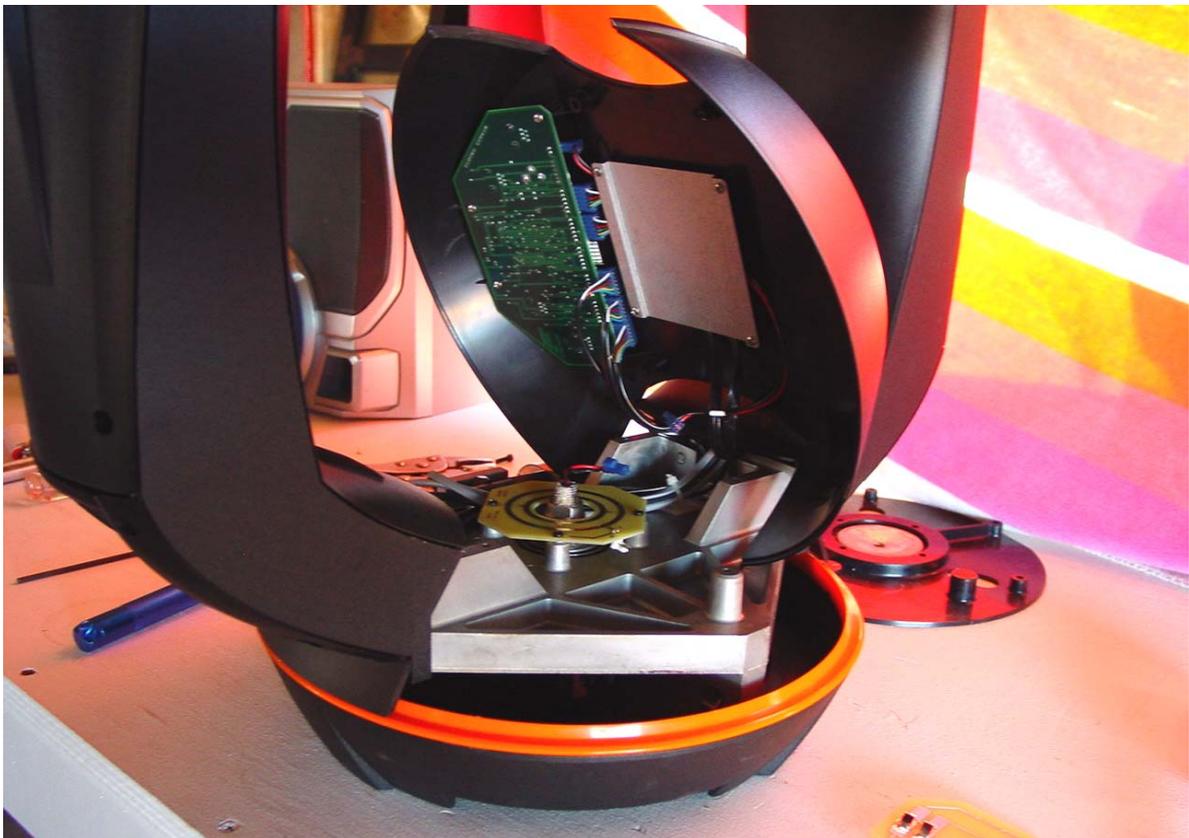
Once you have had a look. Disconnect the two wire connector from the position plates. Then gently pull on the wires going into the fork arm to take up the slack and give you a little room to set the BTC into a better position as shown.

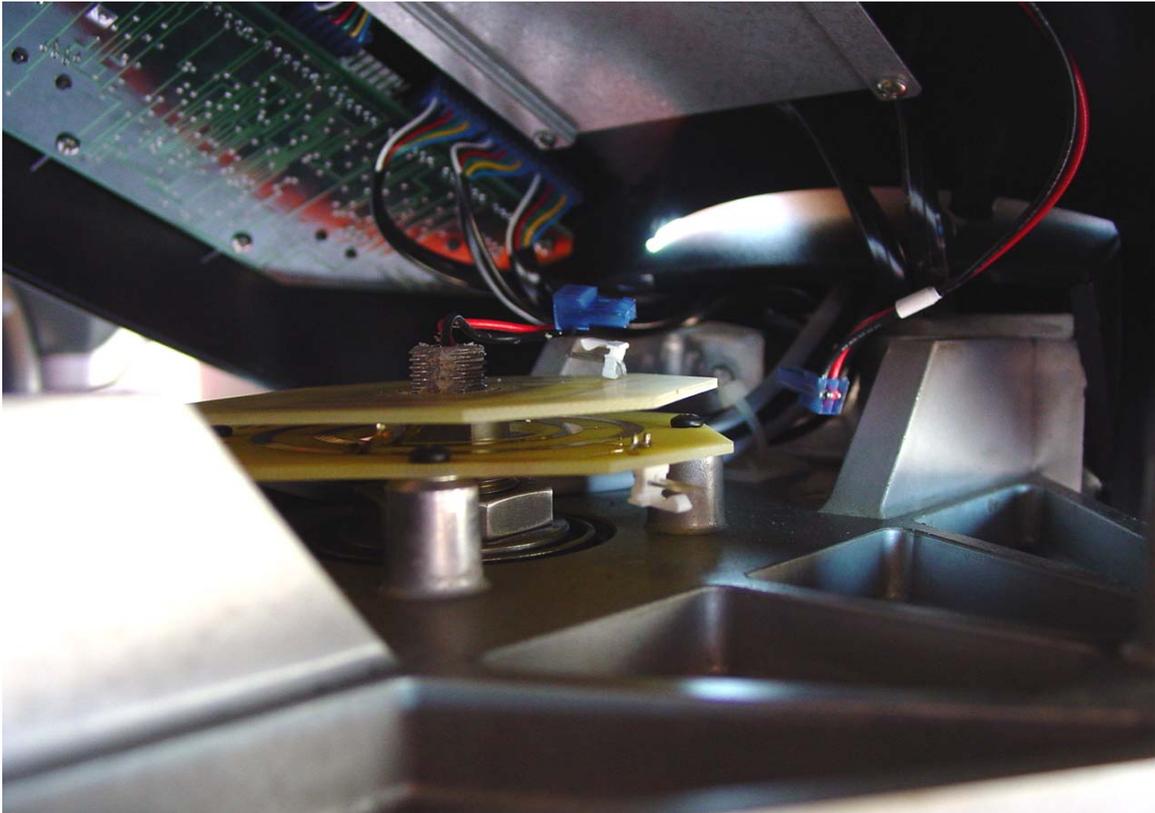
View from right with HC in back.

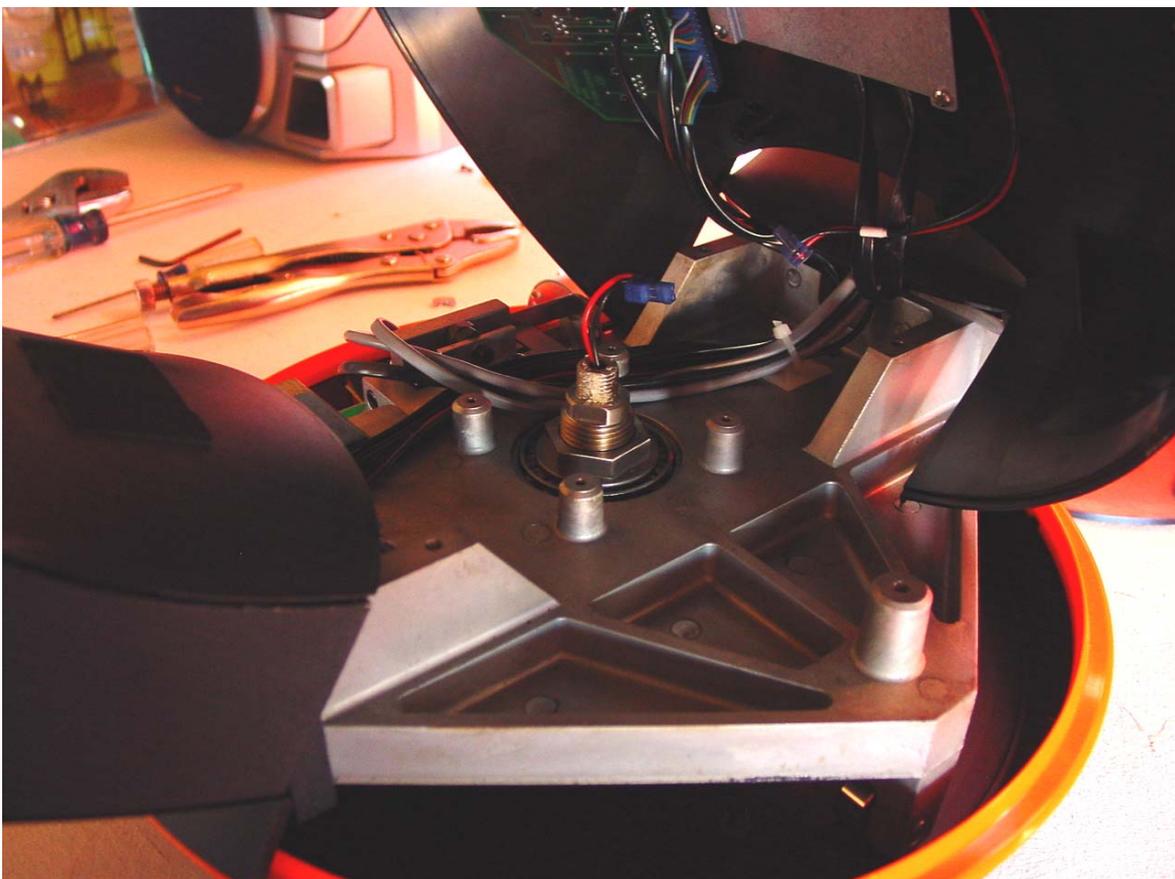
Take the 4, #1 phillips head screws out of the position plates and remove the plates

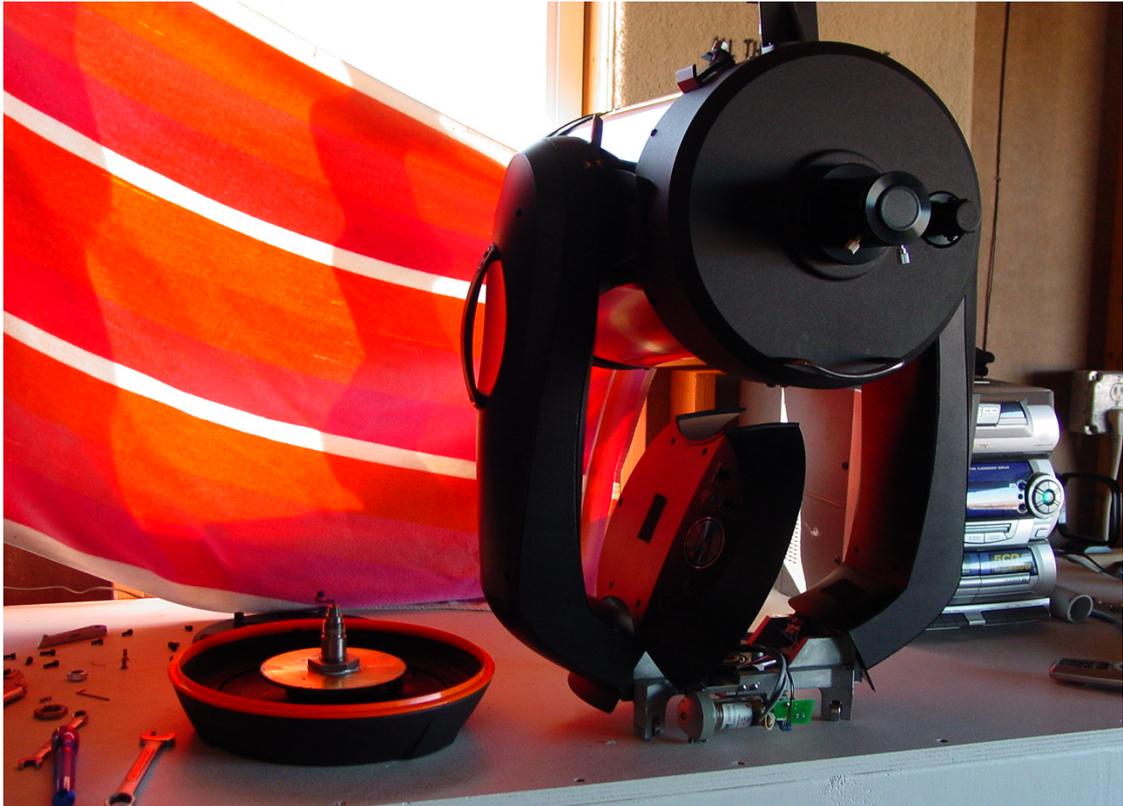
NOTE: Some have reported that too much loctite has been to the threads of some scopes as shown in the above photo. In such a case, the nut is not easily removed and the upper assembly does not just lift off and alternate methods must be used.

I recommend extreme caution and an extra set of hands. Extra force may be required!

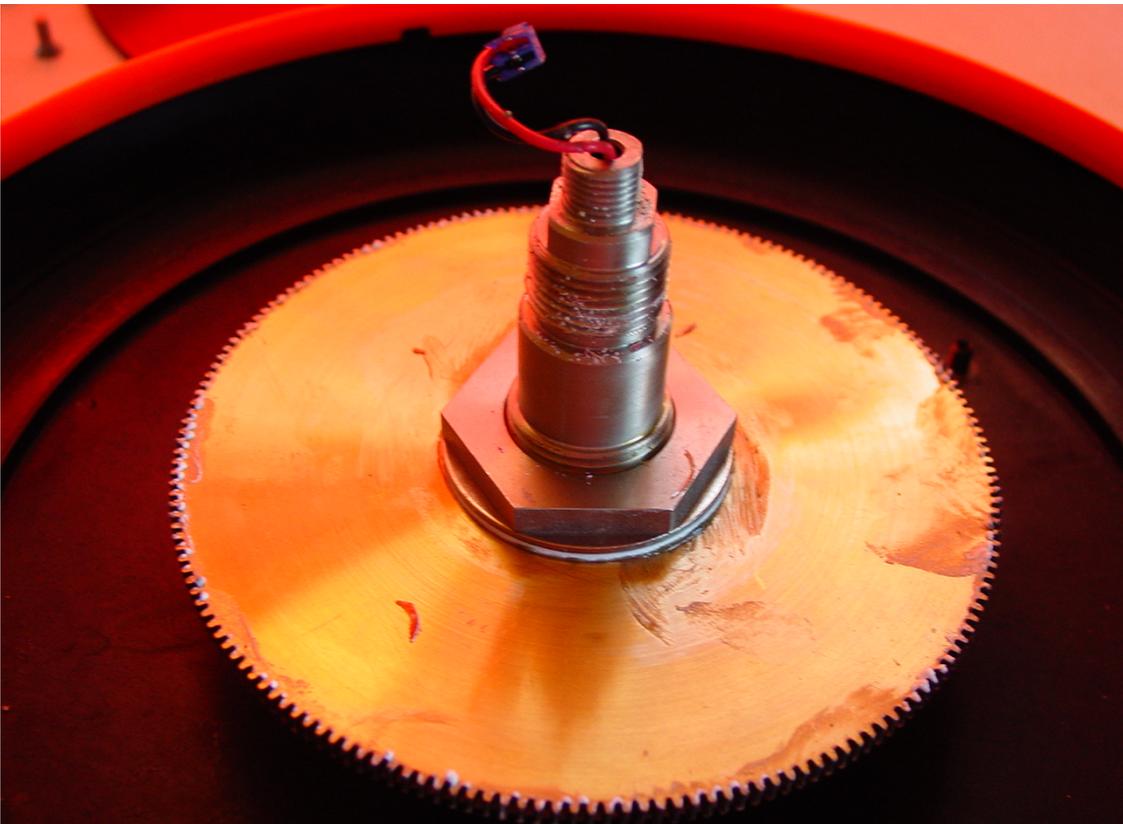
Once you have removed the nut the upper assembly should come right off. Take care in placement so as not to damage the roller bearings it rides on!

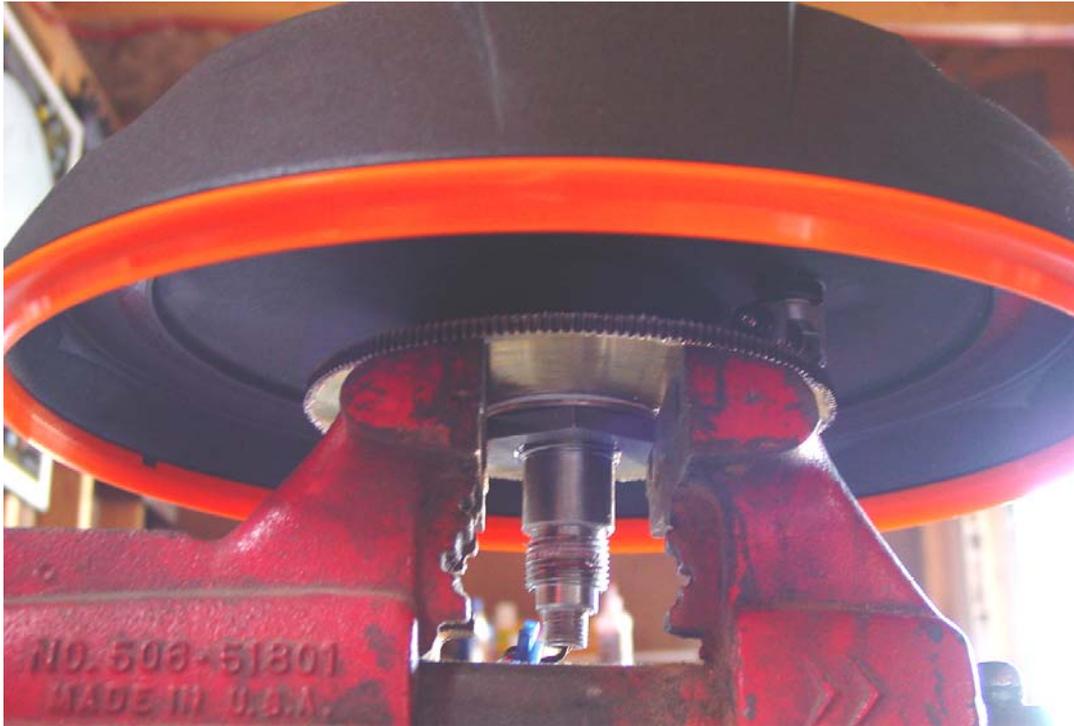
You should now be looking at the azimuth drive gear. Remove the large nut and remove the gear assembly. This is a rather large nut and some of us may not have a tool large enough to remove it...BUT...

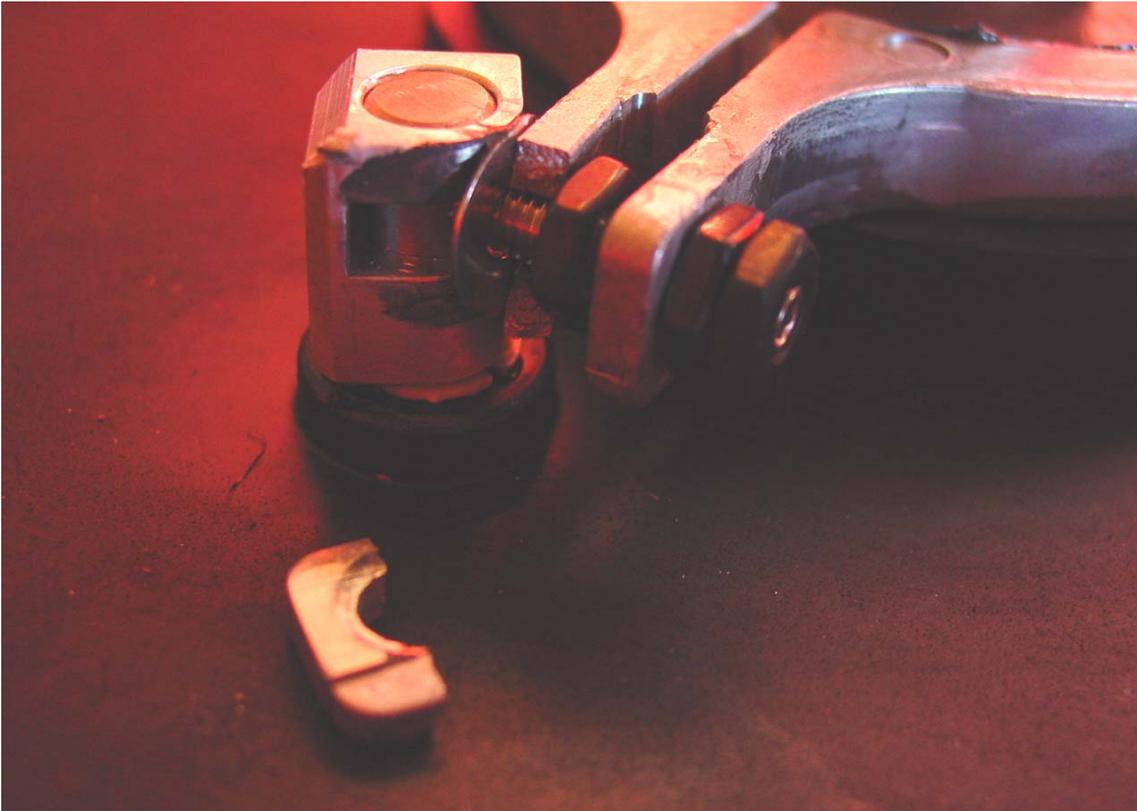
Most likely you will now see what the problem is!

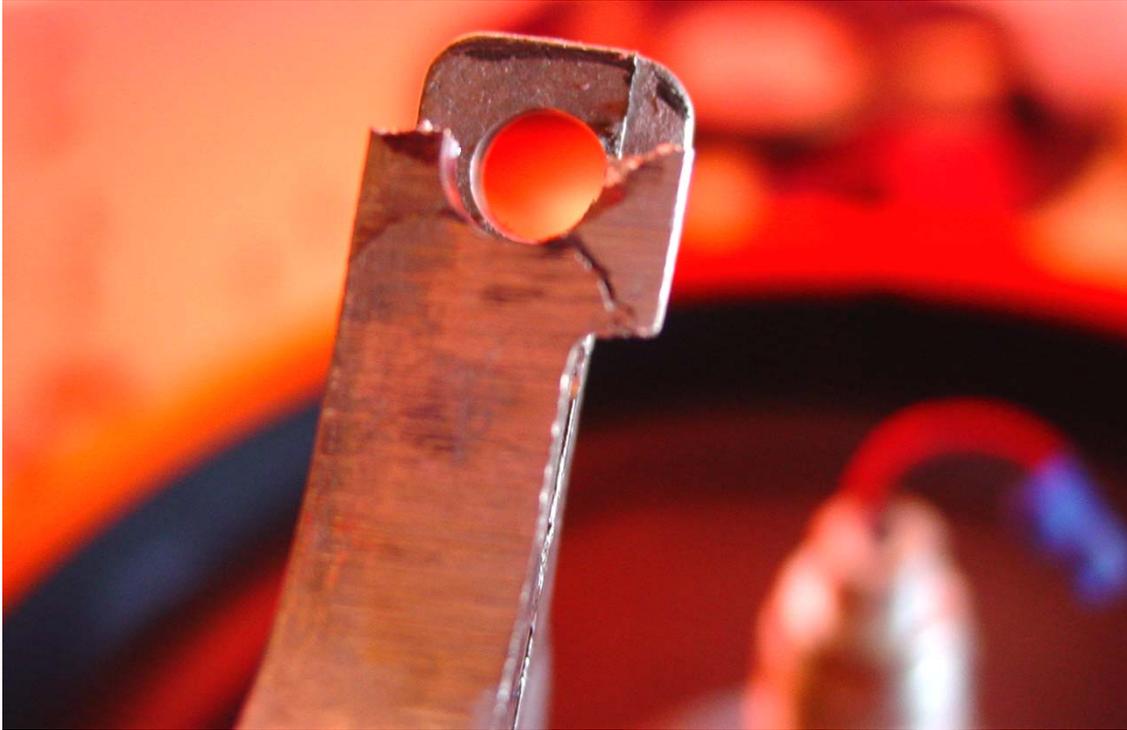
Remove the Clutch and go order the part!

As for my feelings, it was an easy disassembly, but I don't feel this kind of damage should have occurred from normal use, especially when the tension has never been adjusted! Place all of the parts in a clean environment until you get your new parts. I used the giant 80 gallon trash bags and place a beach towel under the bag to keep out the light.
