Old DX-one™ Active Antenna Rebuilt with New Amplifier

„DX-one™ MkIII“

DX-one™ MkIII

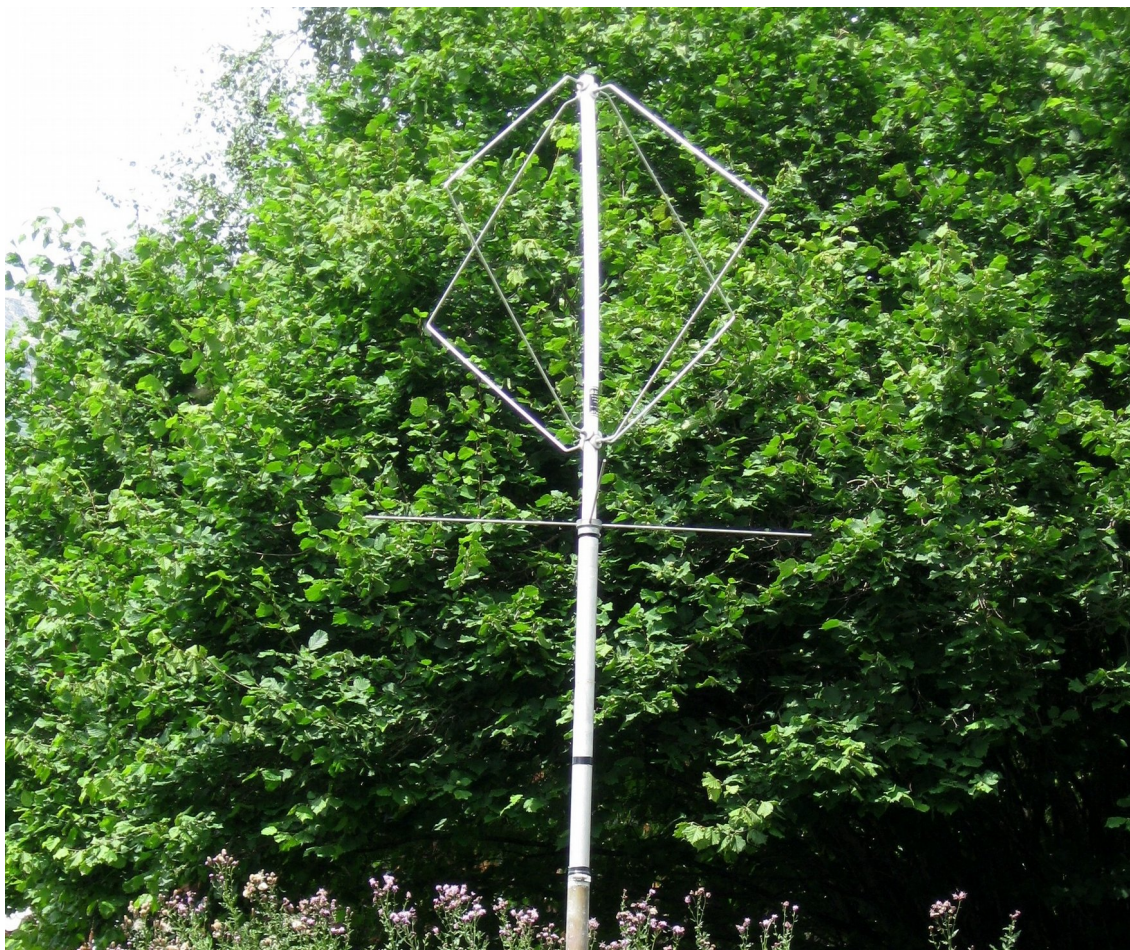
My old DX-one™ (early version) was - and now is again - installed in our remote location which is surrounded by mountains. It sits on a 3m Mast and feeds RF-signals through a 30m RG213/U underground cable to a series of receivers through a R&S antenna distribution amplifier.

Antenna as pictured in 2014

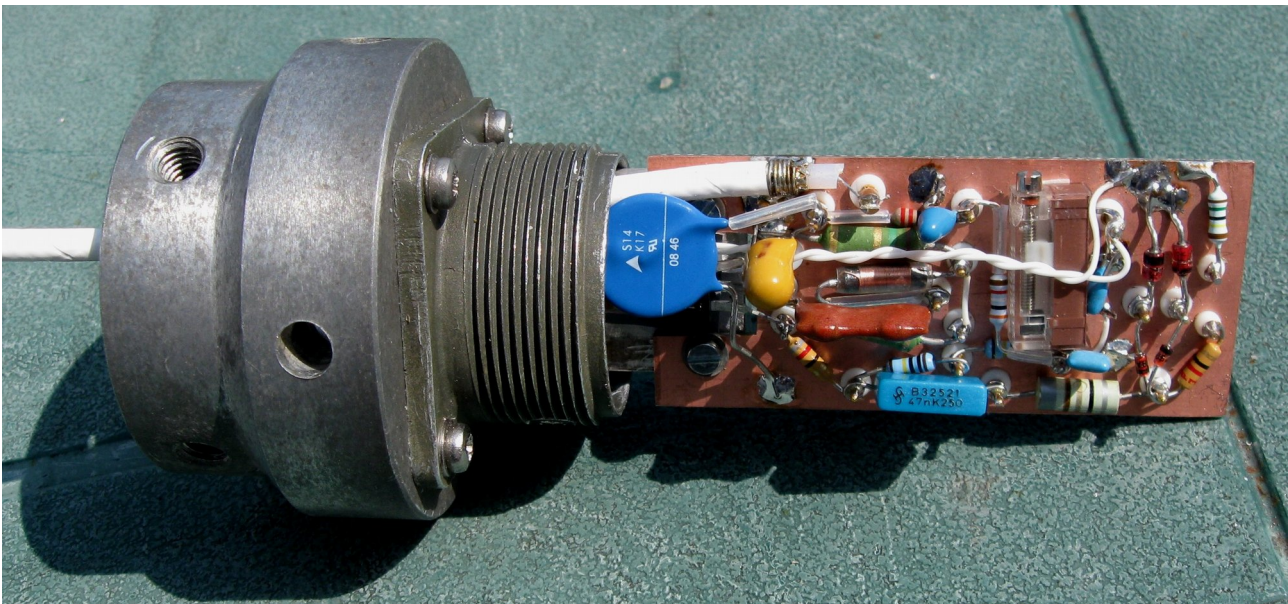
The amplifier is built on double sided epoxy material providing a good ground plane and using Teflon™ insulated support pins pressed into holes for the components. The output transformer is placed on the bottom side to provide good separation from the input.

The amplifier uses the Mitsubishi™ MOSFET RF 30MHz power transistor RD06HHF1 in class A, running at 15V and 300mA. This transistor has successfully been used in linear class A amplifiers².

A solid aluminum block is used to transfer dissipated heat to the round antenna base – a significant improvement to the original design. To further increase thermal stability, DC feedback in the source and a temperature sensing transistor on the heat sink were added.

Top view

The following pictures show the final V1.1 implementation after first two breadboard versions were built. The circuit diagram is to be found at the end of this document.

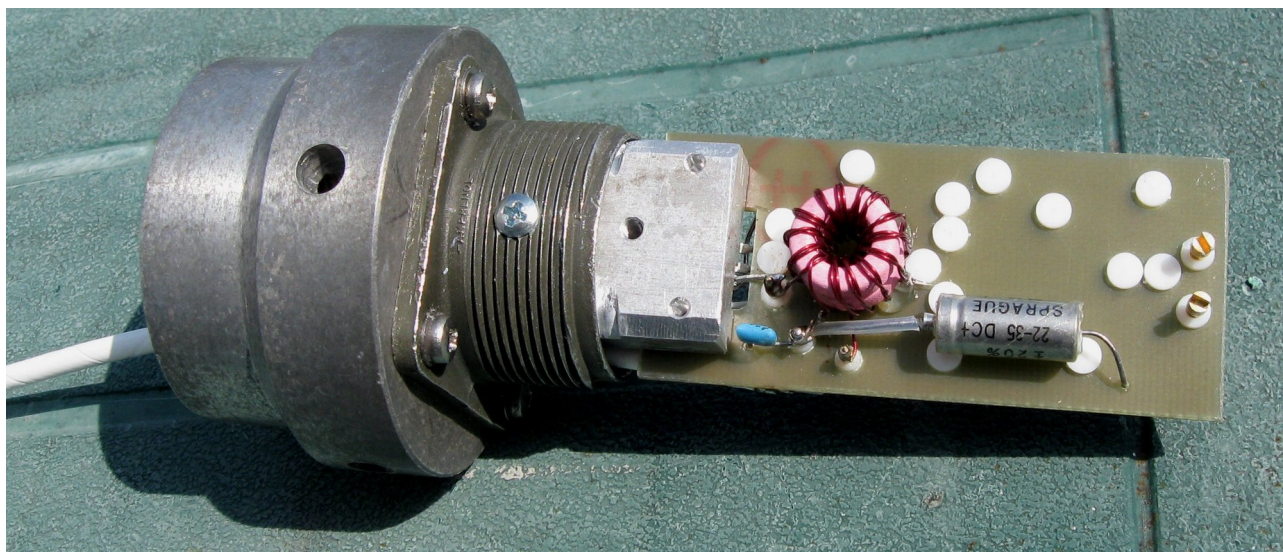
Bottom view

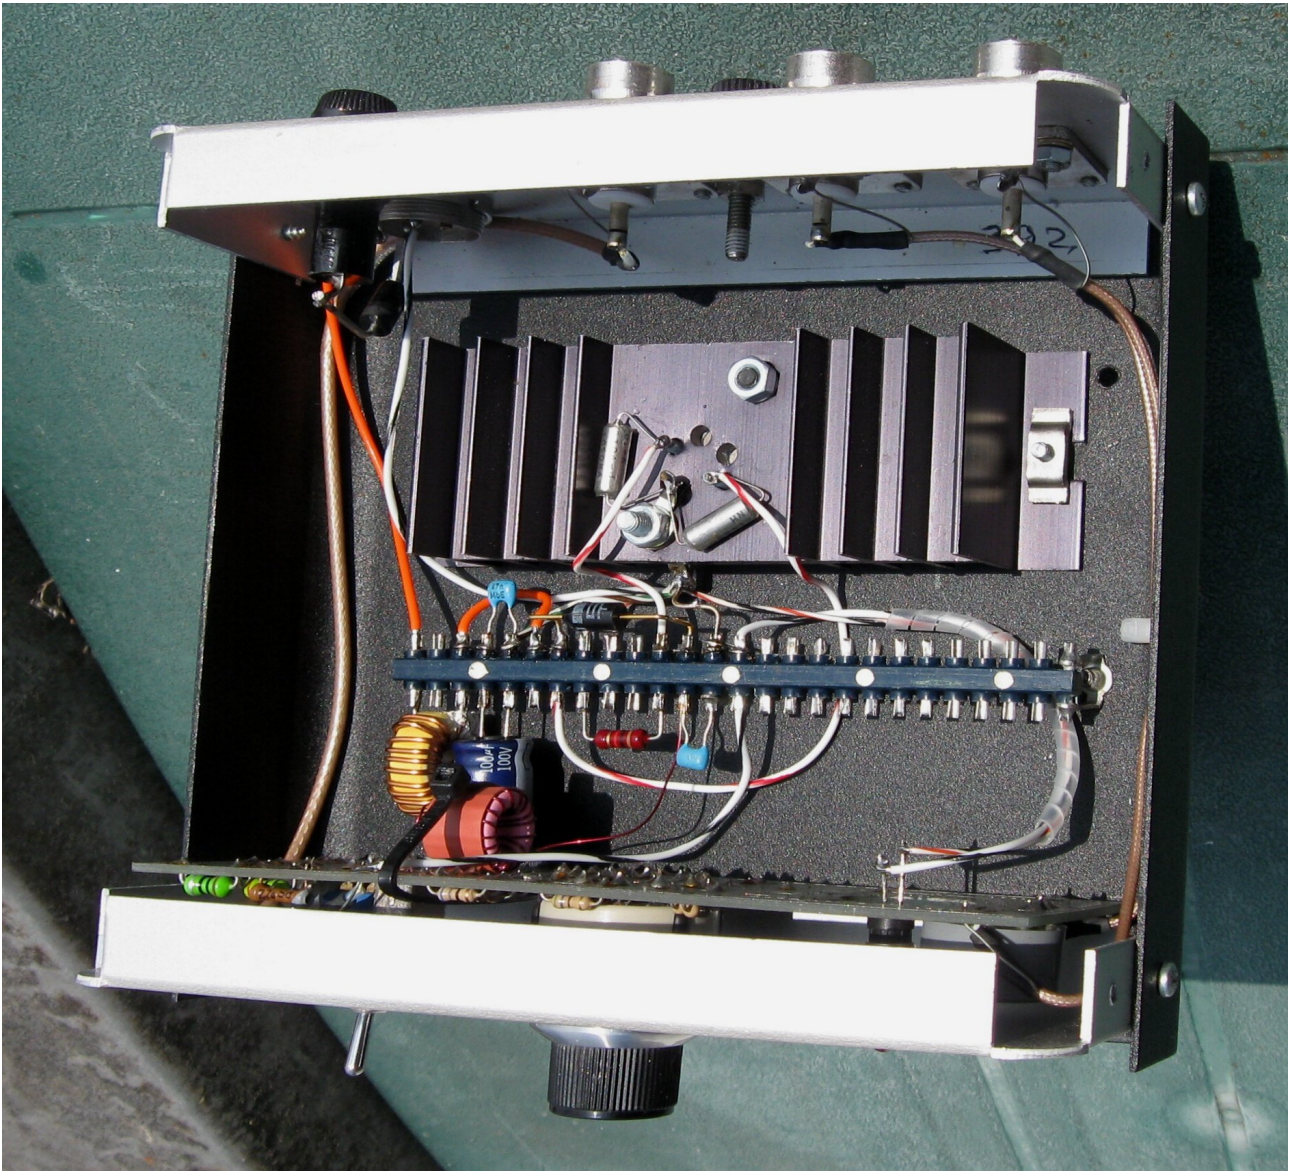
The result is shown in the picture below: a +15V regulator IC provides a short circuit proof supply to the antenna. The series choke to the coaxial cable was also redesigned as the original was found to be underrated for the required current. An input filter on the battery supply attenuates any RF or spikes from entering the circuit (see picture below).

Remote control unit with +15V regulator

The remote unit needs to provide +15VDC rather than 24V as before and in my case also is supplied by the +28V rail from a battery (in nice weather charged by solar panels) rather than AC mains.

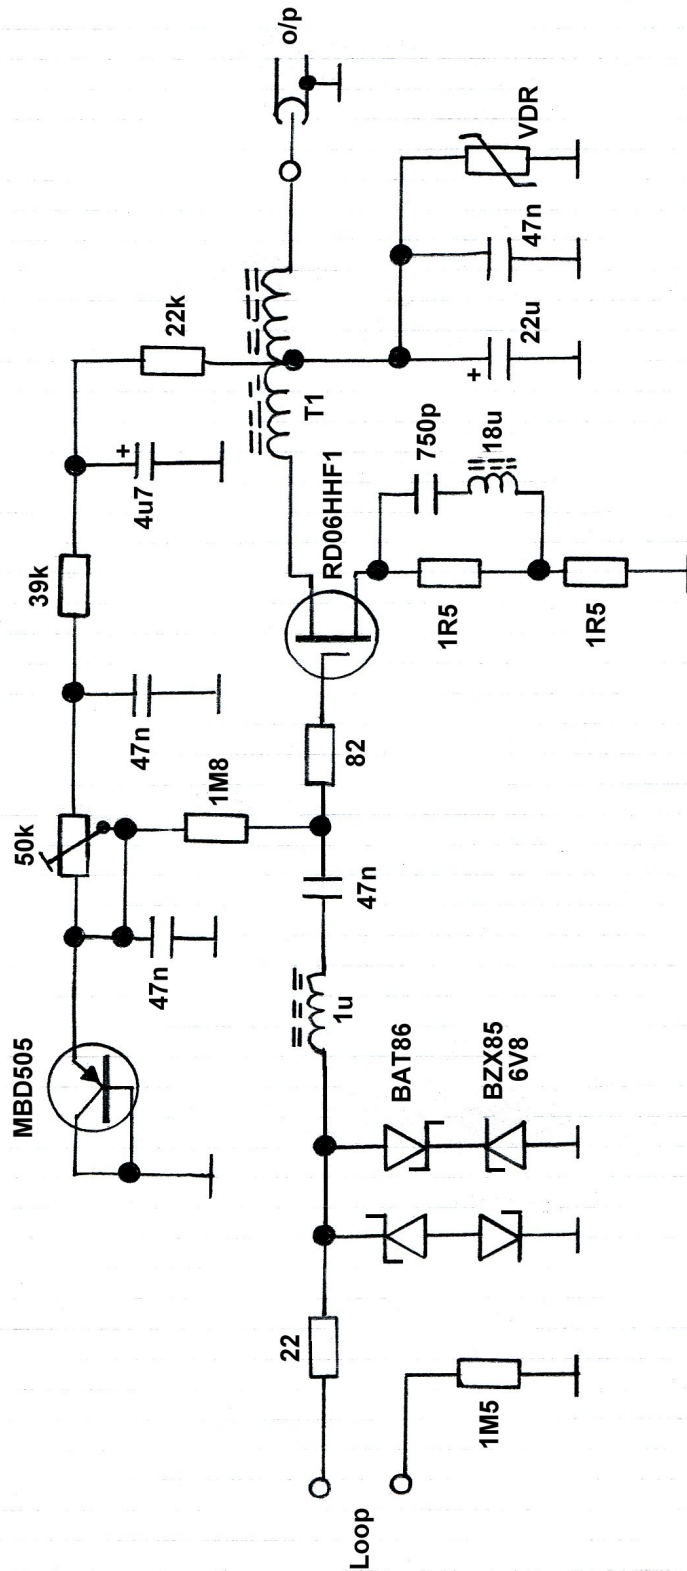
hb9aik - vk6bqd/V1.1

Active Antenna Amplifier, Circuit Diagram
 (As used in DX-one™ MkIII)

Note: The „Loop“ is actually a figure-8-folded wire, one end terminated with 1.5Mohm to ground and the other end connected to the high-impedance amplifier input. The DX-one™ is not a magnetic loop but rather a cleverly designed capacitive antenna.

Frequency compensation and negative feedback are placed in the source of the MOSFET so that a satisfactory frequency response to well over 30MHz is achieved.

Input to the gate is protected by Schottky diode/zener pairs and the power input clamped by a VDR. An input choke and series resistor prevent potential VHF oscillations.

The diagram on the following page shows the earlier described and pictured circuit of the new amplifier. No diagram is shown for the power regulator.
